Diagnosis and repair of cracking to an old 1880's concrete house for Channel 4 Television, UK

ABSTRACT: Michael Grantham was initially approached in October 2010 by the owner of an old concrete house which was suffering from severe cracking. The house was due to feature on national television in a programme called "Help my House is Falling Down!" which is broadcast at prime time on Channel 4, one of the main UK TV channels. Subsequently, we were asked to appear on the programme and to conduct insitu and laboratory tests to determine the cause(s) of cracking and to help with remedial suggestions. The cause of cracking was very unusual and quite complex, resulting from a combination of expansion due to the use of old foundry waste as an aggregate and also due to cracking due to a lack of restraint in the walls.

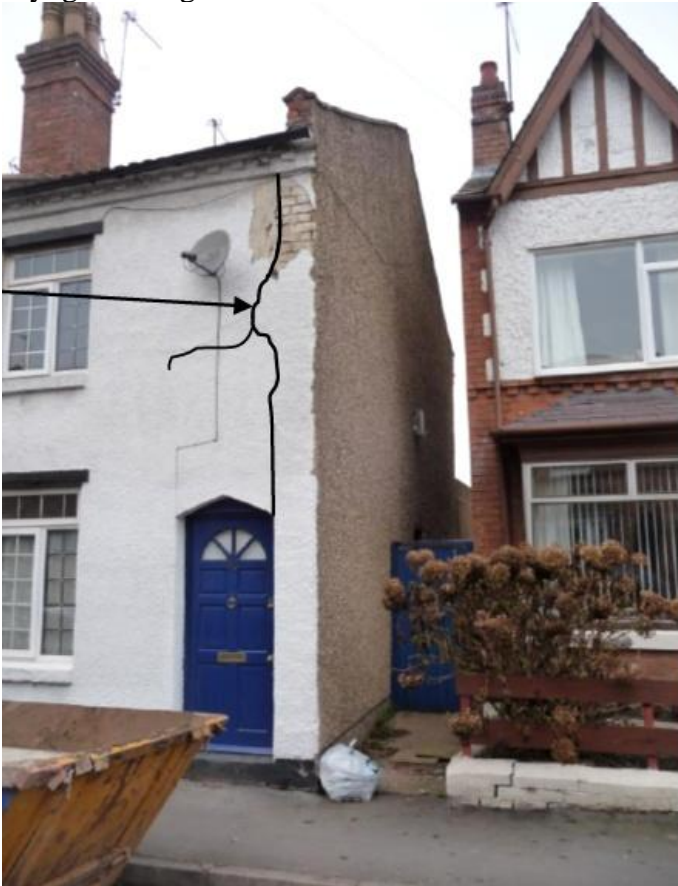
The visit to the property was made in November 2010. Inspection of the house externally revealed cracks up to 8mm in width, notably between the gable end wall and both the front and rear walls, where the gable end wall appeared to be moving outwards at the top and splitting away from the front and rear walls, more seriously so at the front (Figure 1).

Figure 1. House showing crack (inked over) between gable wall and front elevation

The final solution chosen involved providing additional lateral restraint using a combination of bow tie and helical stainless steel fixings between the gable wall and front and rear walls. These were installed in and around the positions of the most serious fractures in the external wall fabric.

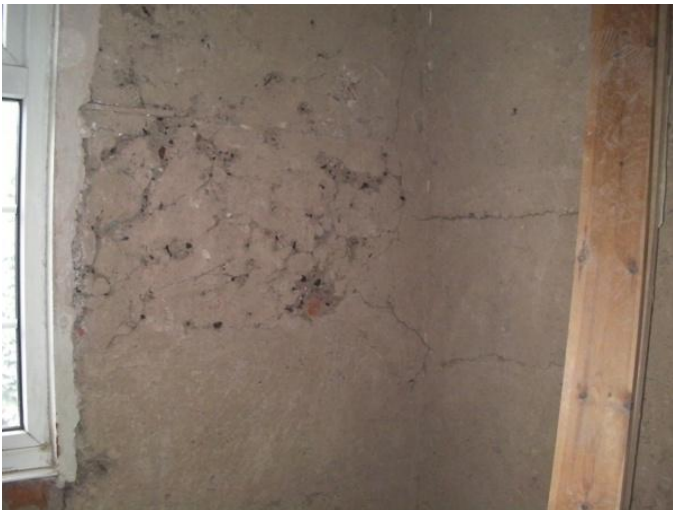
Internally, the plaster had been removed from the upper rooms but was still present on those downstairs, rendering inspection of the hidden surfaces impossible. Upstairs, a band of severe cracking was present on the front and gable walls, about 1m deep at mid height in the wall (extending approximately from top to bottom of the window right round the

wall (Figure 2). Inspection of the rear bedroom showed a similar problem. It was possible to see daylight through some cracks!

Figure 2. Internal cracking in concrete in upper wall

In addition to this, cracks in the walls were sealed with resin injection, the walls were stripped of render and insulated cladding applied, followed by reinstatement of the rendering. Internally, the weak defective band of concrete on the first floor and also the weak material on the gable wall in the loft was removed to about 75mm depth in sections and replaced with a hand applied concrete repair mortar, allowing each insertion of repair material to set and harden, before proceeding with the next part. Finally, carbon fibre strips were added to walls to provide additional tensile strength to supplement the capability of the external wall to withstand wind pressures, prior to replastering.

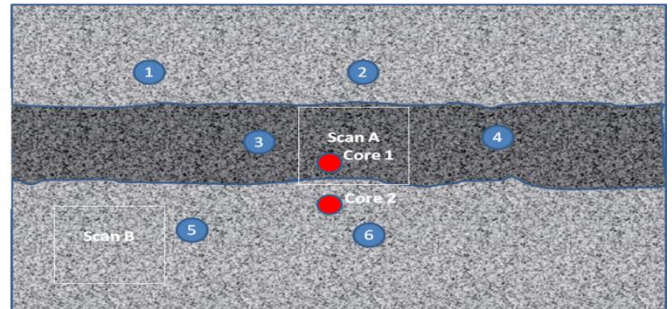
Gable Wall, 1st Floor, Test Locations and Heavily Deteriorated Band

Figure 3. Schematic showing core sample and PUNDIT and Schmidt Hammer test locations

The Schmidt Hammer values showed low results for positions 3 and 4 in the centre, deteriorated, band and interestingly also at Position 5, in the visually better concrete nearer to floor level.

The ultrasound results all showed rather poor quality concrete (good concrete would be expected to show values in the 4km/s region, or better). All tests were undertaken using indirect transmission (from the same side of the wall, rather than through it, as the rough surface of the pebbledash rendering made it impossible to take readings through the wall). The reliability of indirect readings is poorer than those using direct transmission.

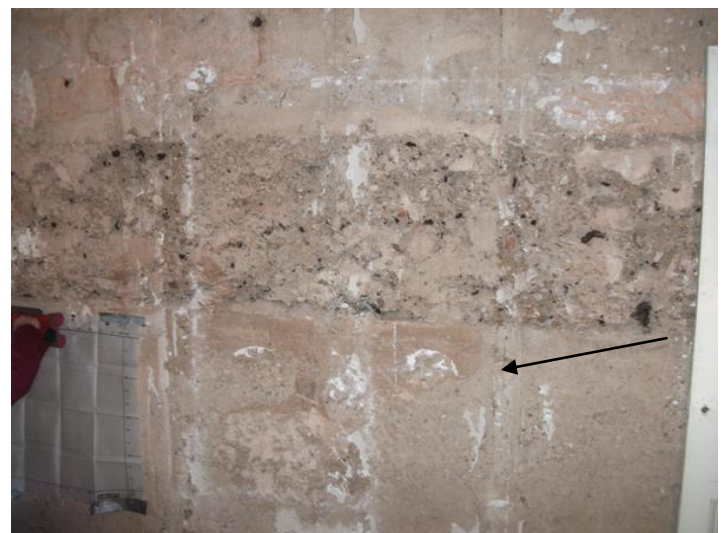
Of special interest was the presence of several vertical cracks in the concrete underneath the heavily deteriorated band. These were a clear implication of expansive movement of the concrete in the deteriorated band, causing a tensile stress in the zone of concrete underneath (Figure 5)

Figure 5. Tensile crack (arrowed) in concrete below centre deteriorated band - the crack did not extend into the centre band.

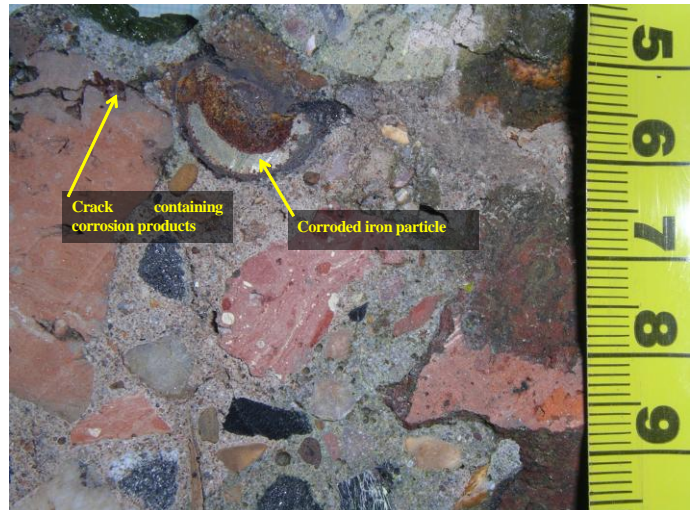
This had coarse aggregate that contained a very wide range of materials that included siliceous gravel, carbonaceous aggregate particles (coal/part-burnt coal/coke) and particles resembling slag. There were also metallic iron fragments and siliceous gravel. The iron particles were commonly corroded around their surfaces and corrosion-stained cracks sometimes appeared to originate from the metallic iron particles. Many of the aggregate particles in this sample were porous and weak.

Figure 6. Corroding iron particle and associated cracking in deteriorated core.

- The weak and friable nature of the cement paste: This is regarded as being a result of a high water/cement ratio and also high void content / poor compaction.
- Metallic iron: The expansion associated with the corrosion of metallic iron accounted for some of the cracking in Core 1 (Figure 7). The observed large iron fragments seen at site were also considered to be a factor in more extensive cracking elsewhere in the structure.
- Coal / part burnt coal: The deteriorated core contained small amounts of coal and part-burnt coal particles. Coal particles are potentially capable of giving rise to expansive cracking when subjected to cycles of wetting and drying.

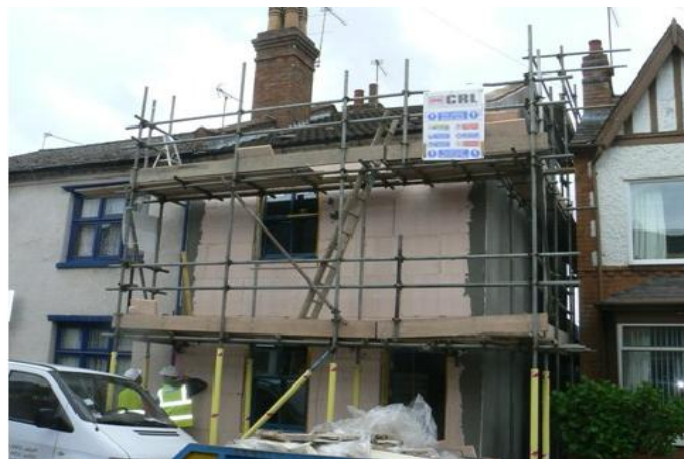
Figure 7. Rendering removed and insulated cladding being installed

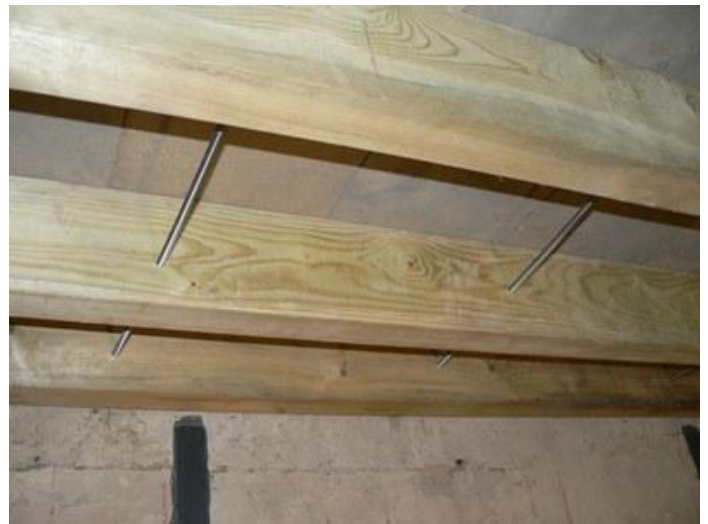
Figure 8. Helical stainless steel fixings to restrain gable wall

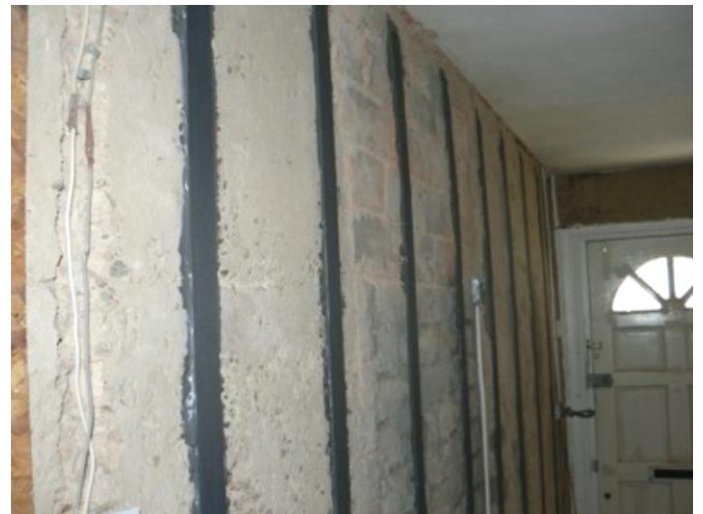
Figure 9. Carbon fibre strips glued in place with epoxy resin to provide additional strength to gable wall

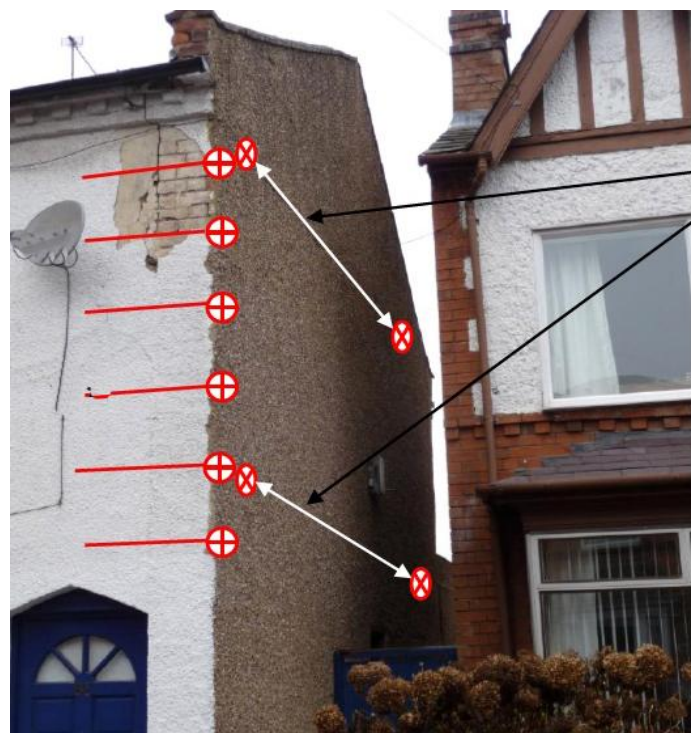
Figure 10 showing details of bow tie fixings at 600mm vertical centres (black arrows) tied into joists. 1200mm long CemTies installed through gable wall into both front and rear walls, generally at 450mm centres.
