High-Alumina Cement Concrete

Assessing HAC

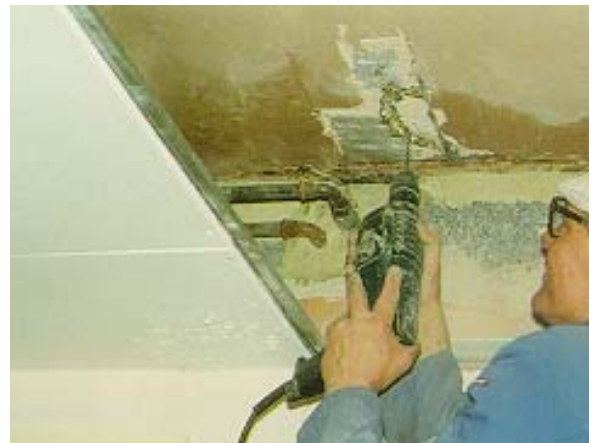
One sampling technique with minimised damage and disturbance

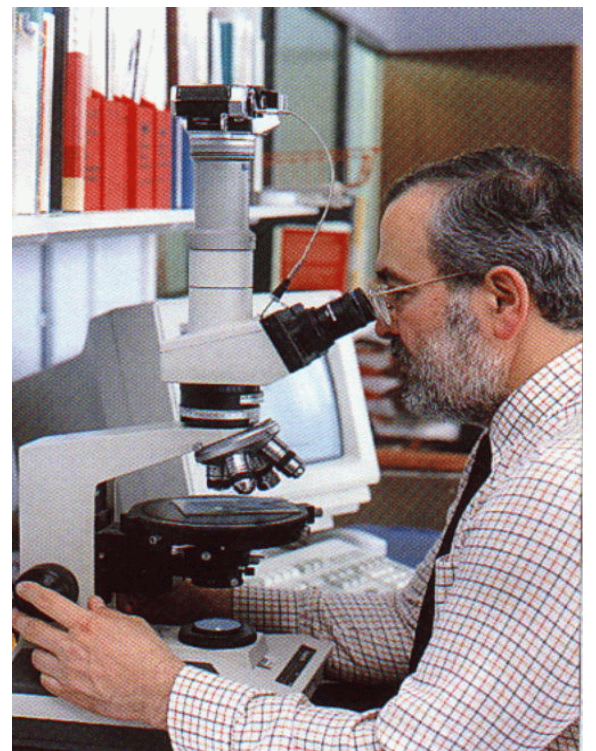
Microscopical examination of thin-section
