Metallurgy

Lighting Column Testing Programmes

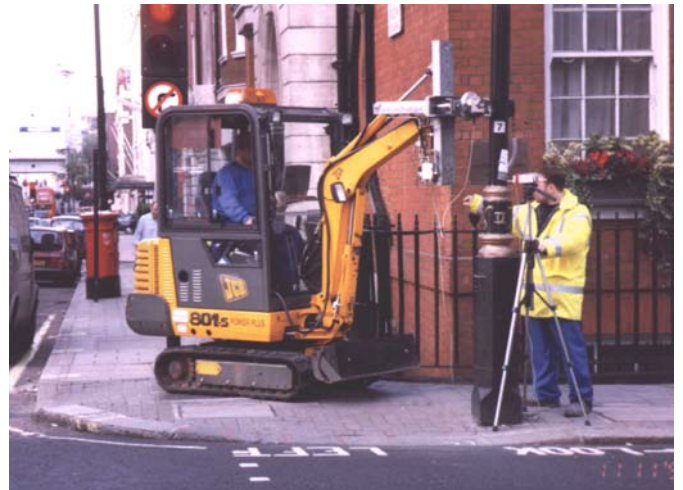
In situ load testing of a column carried out in conjunction with our partner, Roch Services Ltd

In conjunction with Roch Services Ltd, our surveys have recently included a new innovative method for determining the integrity of these columns. The system involves the non-destructive testing of the column and assessing the integrity of the column's base section, both above and below ground.

This rapid in-situ load test is carried out with minimal disruption. The results form a useful part of our appraisal of the column's condition. In conjunction with other testing procedures such as ultrasonics and visual inspection, our reports identify which columns are most at risk, and recommend which columns should be removed. The testing can also immediately identify those columns at risk of imminent failure.

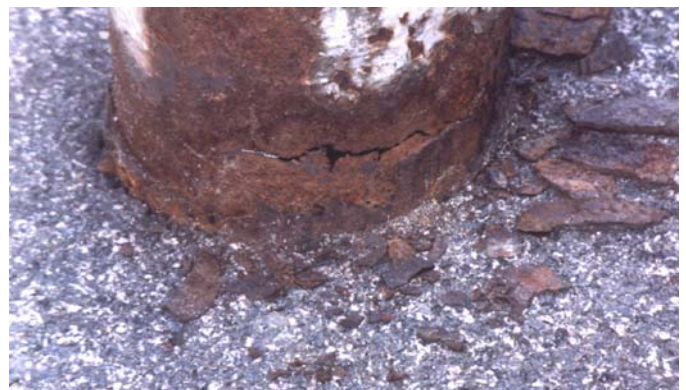
Poor condition of a column base. As can be seen from the surrounding debris, this crack was not revealed until the superficially sound surface was removed.

The problems detected during our testing programmes are often well concealed, to the extent that a less technical inspection, such as that carried out by an Authority's Term Maintenance Contractor, should not be expected to discover significant defects. As an example, loss of section is often difficult to identify since it can occur just below ground level. Furthermore the corrosion may be hidden by a non-structural decorative skirt or be most prevalent on internal surfaces which are difficult to access.
